ENVIRONMENTAL TEST REPORT

G. P. WILLIAMS INC.

SERIES/MODEL: Drain Plain Siding Backer
PRODUCT TYPE: HDPE Cladding Spacer

Report No.:	76985.01-201-23
Test Dates:	09/24/2007
Through:	09/27/2007
Report Date:	10/12/2007
Expiration Date:	09/24/2011

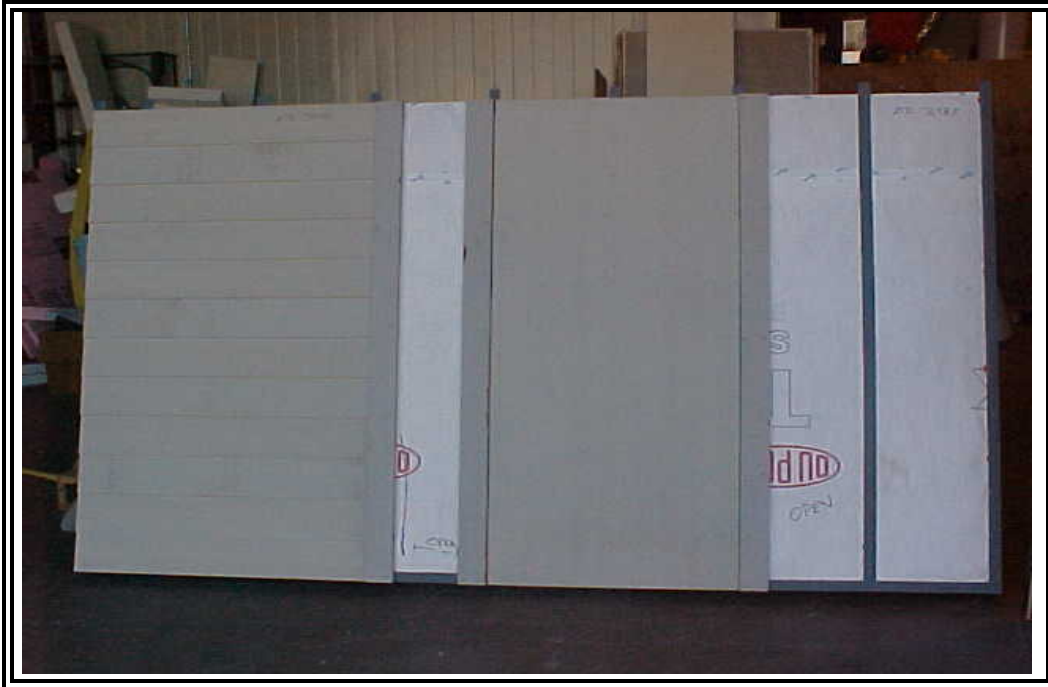
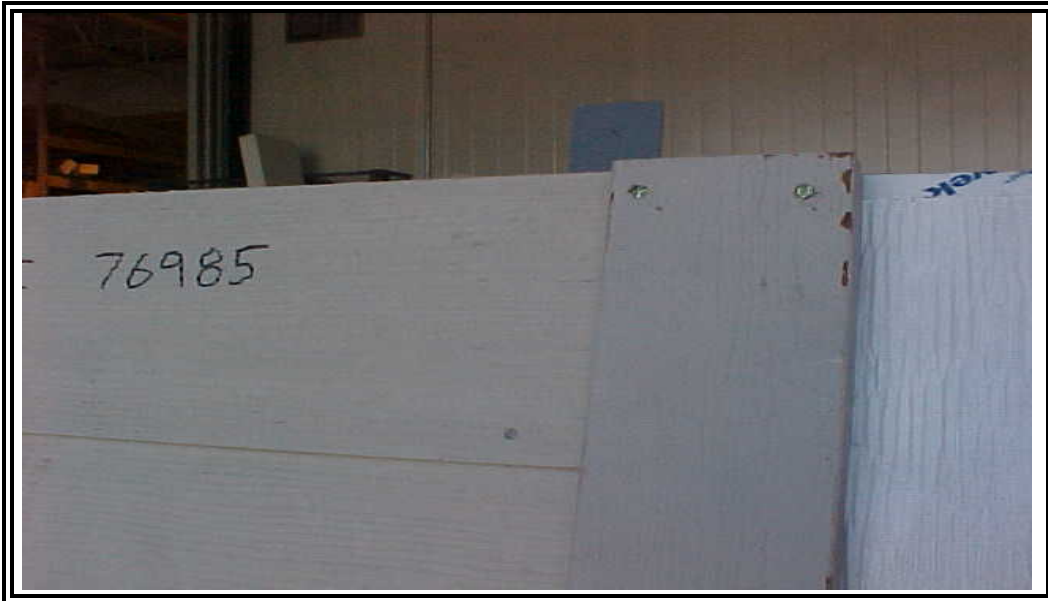
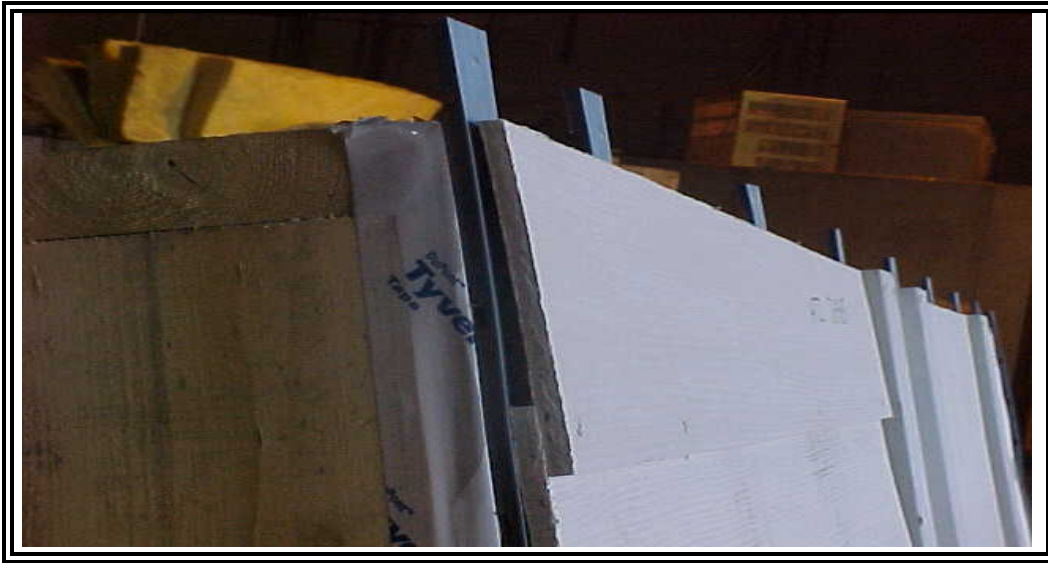
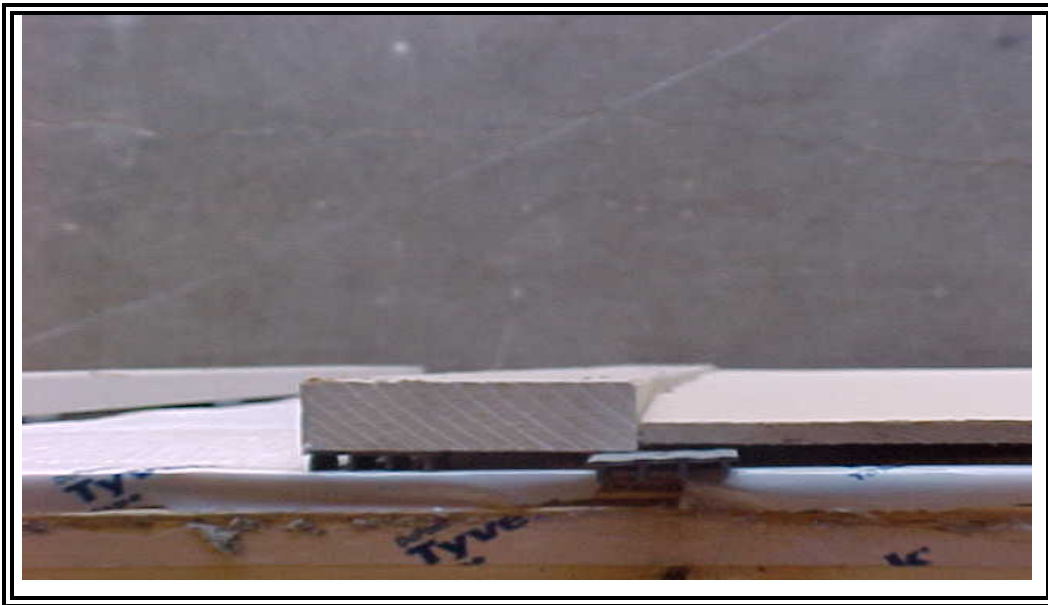
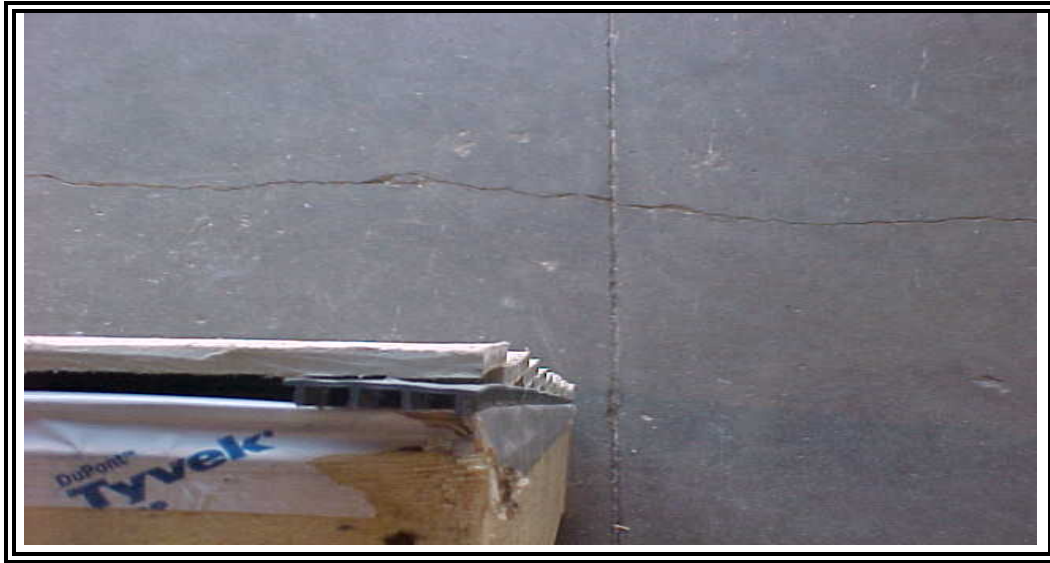
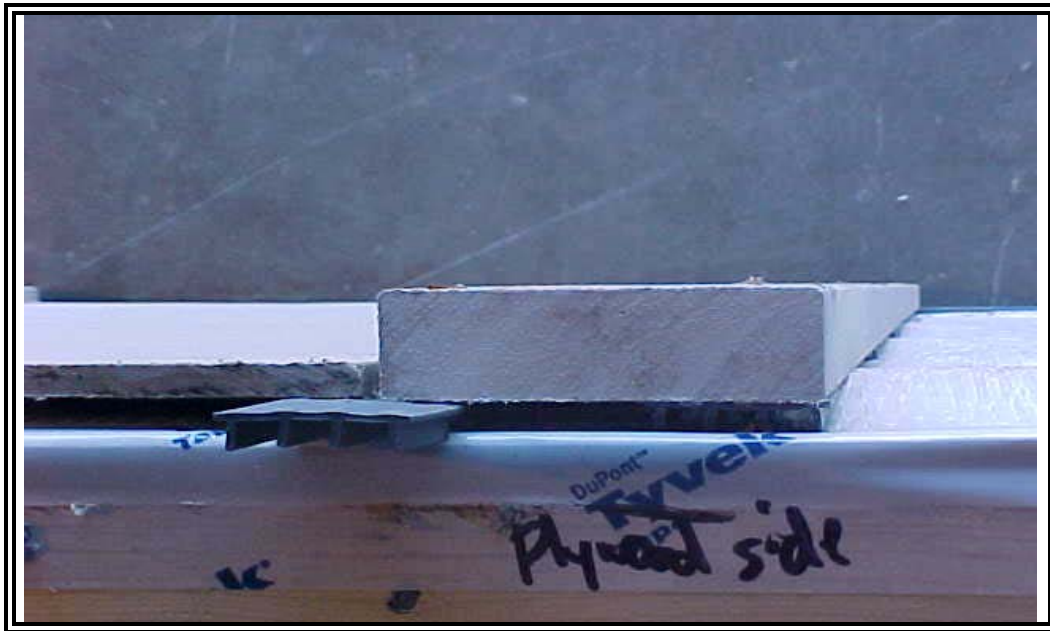
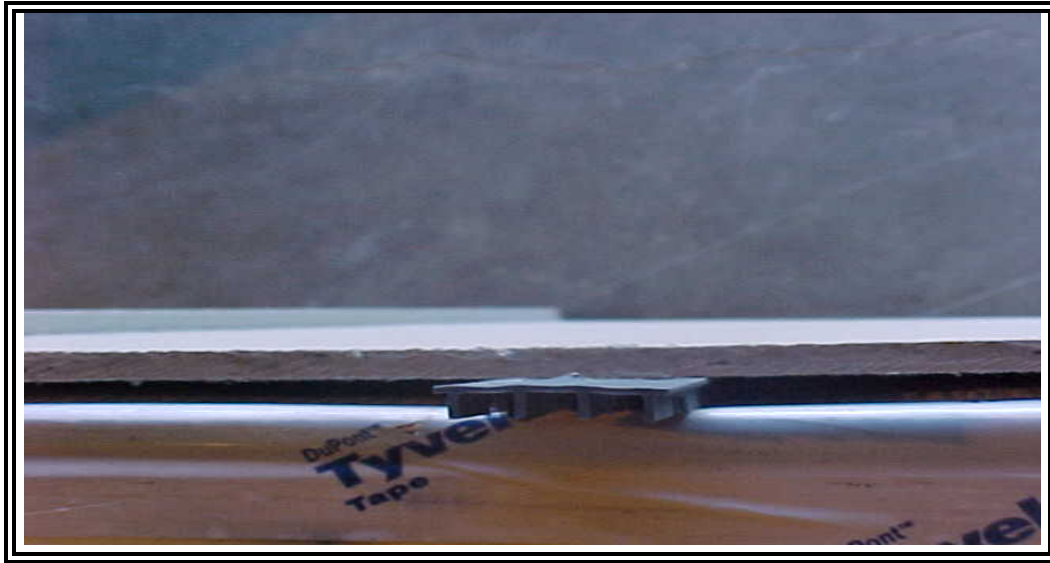
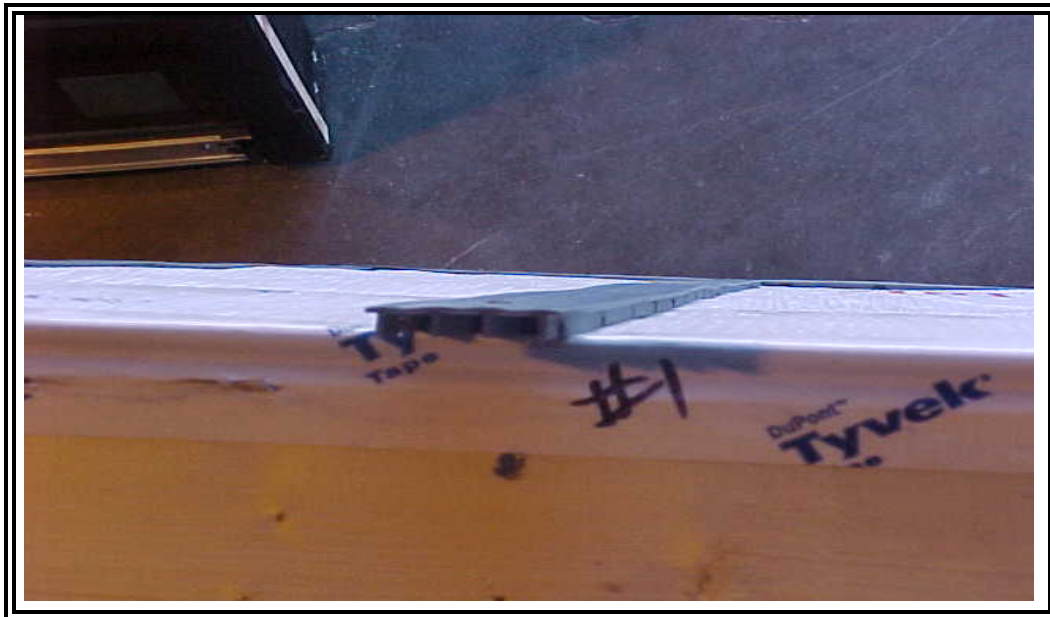
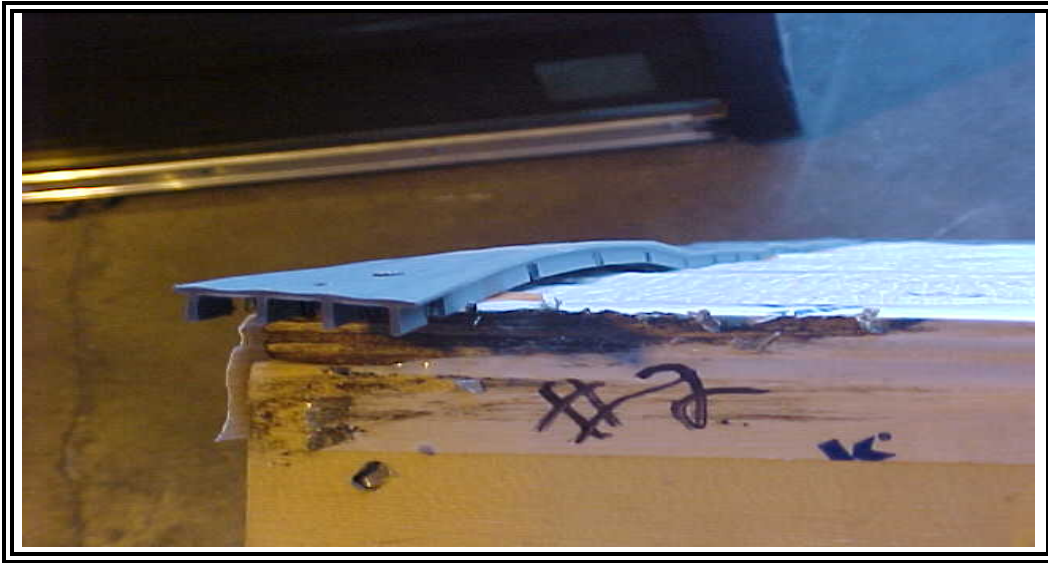
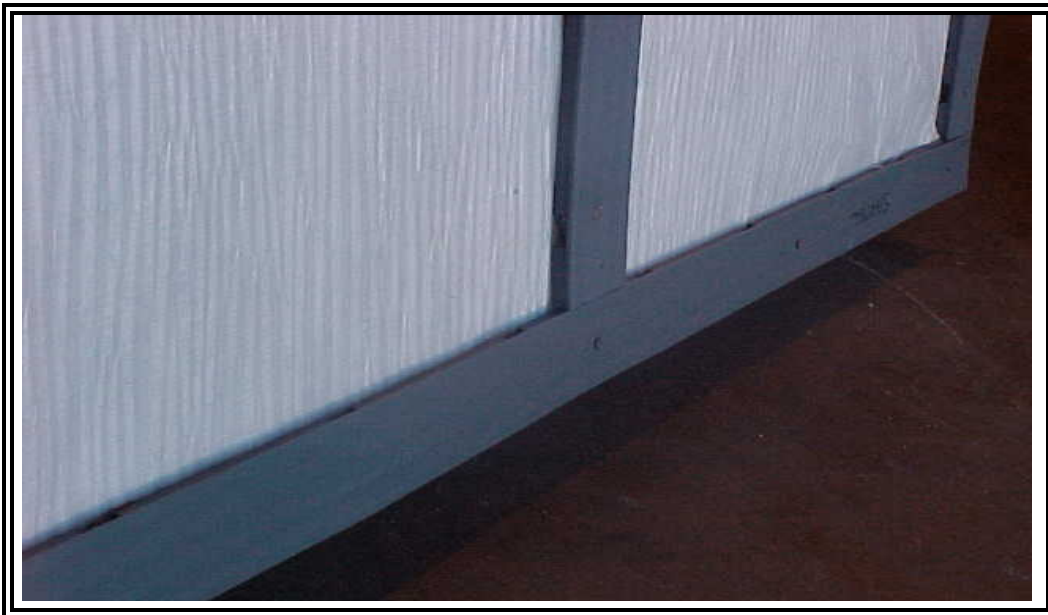
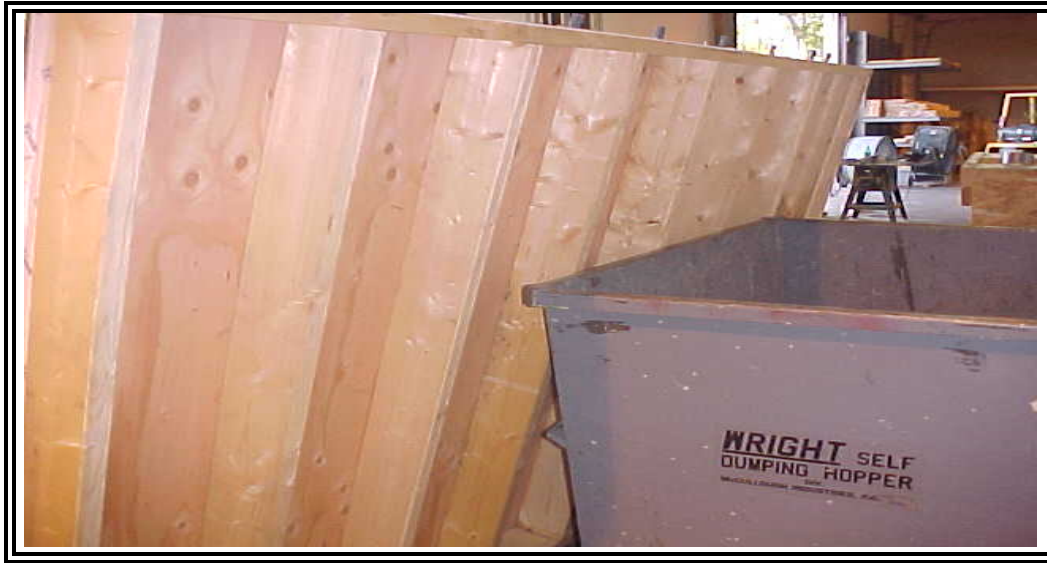
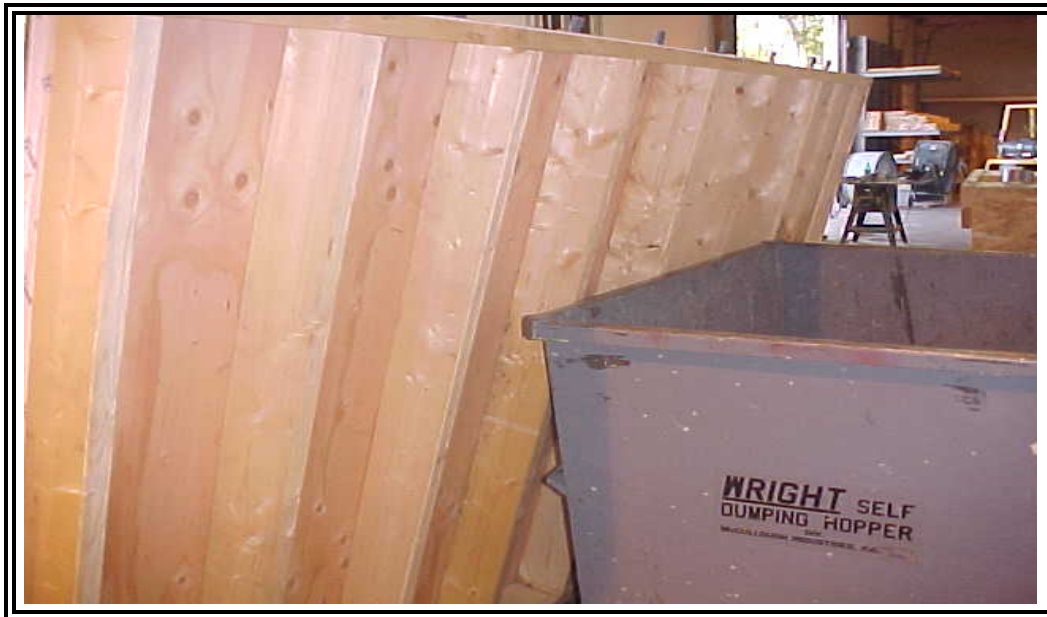
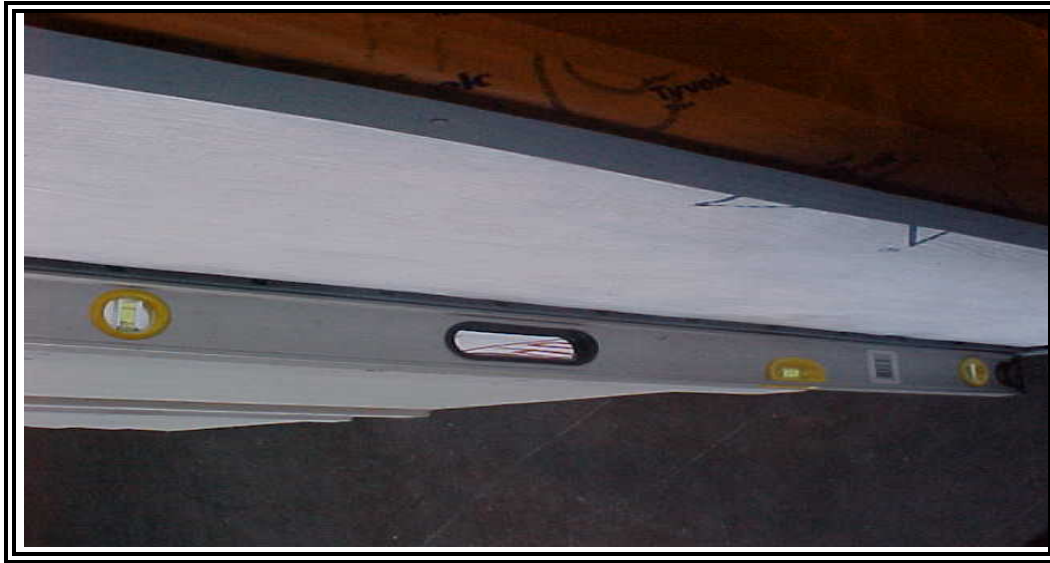
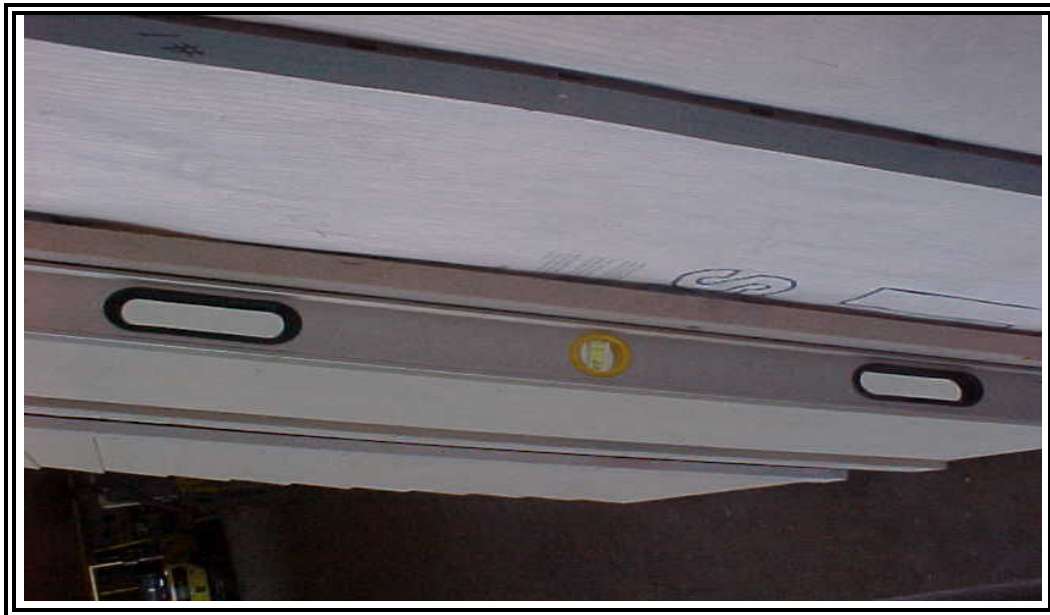
Appendix A
Photos (Pre Test)

Mock-up Description: A 120" by 72" stud wall was constructed using nominal 2" x 6" studs spaced 16" on center, sheathed with 1/2" plywood, and covered with Tyvek weather barrier. Vertical strips of the HDPE Drain Plain were nailed over the Tyvek into studs with 8 penny rim-shank nails spaced every 12". Two types of siding were installed in sections and bordered with a 1" x 4" Miratec trim board. The first section was 6" fiber cement lap siding and the second a flat, one piece, fiber cement sheet. Two strips of the HDPE backer were left uncovered. (See photos)

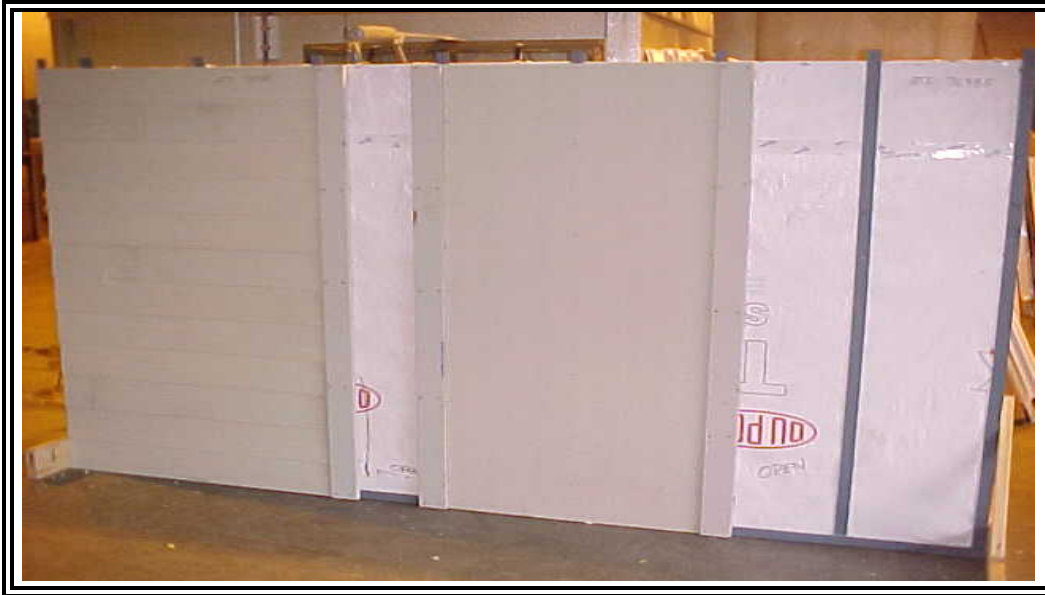
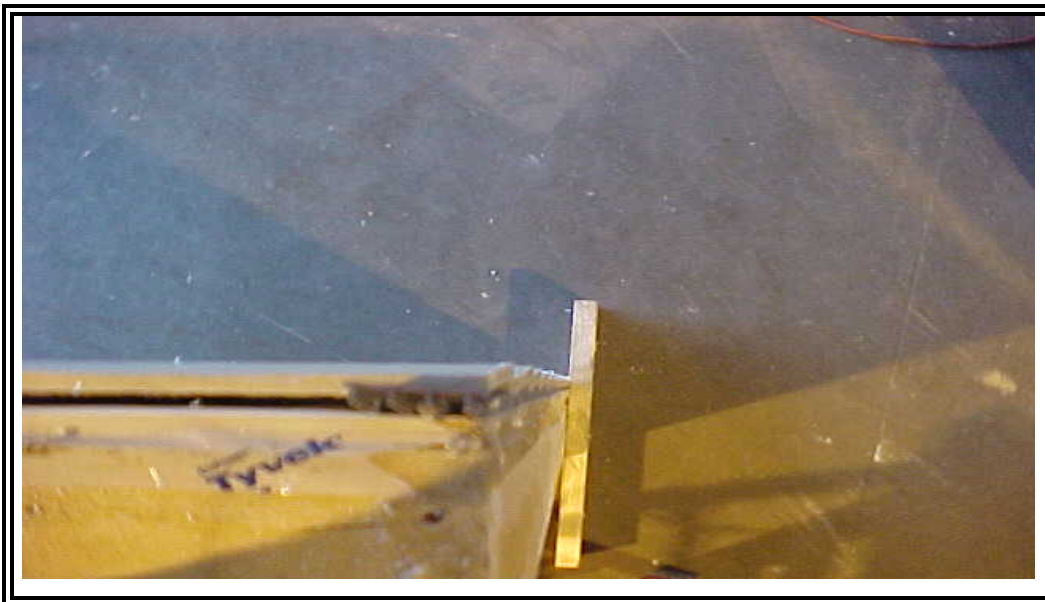
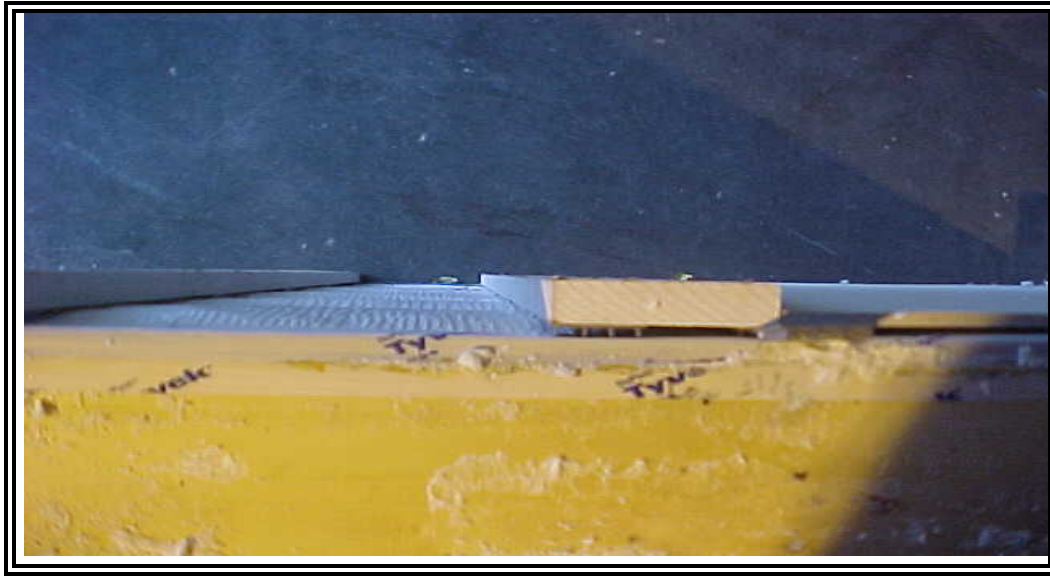
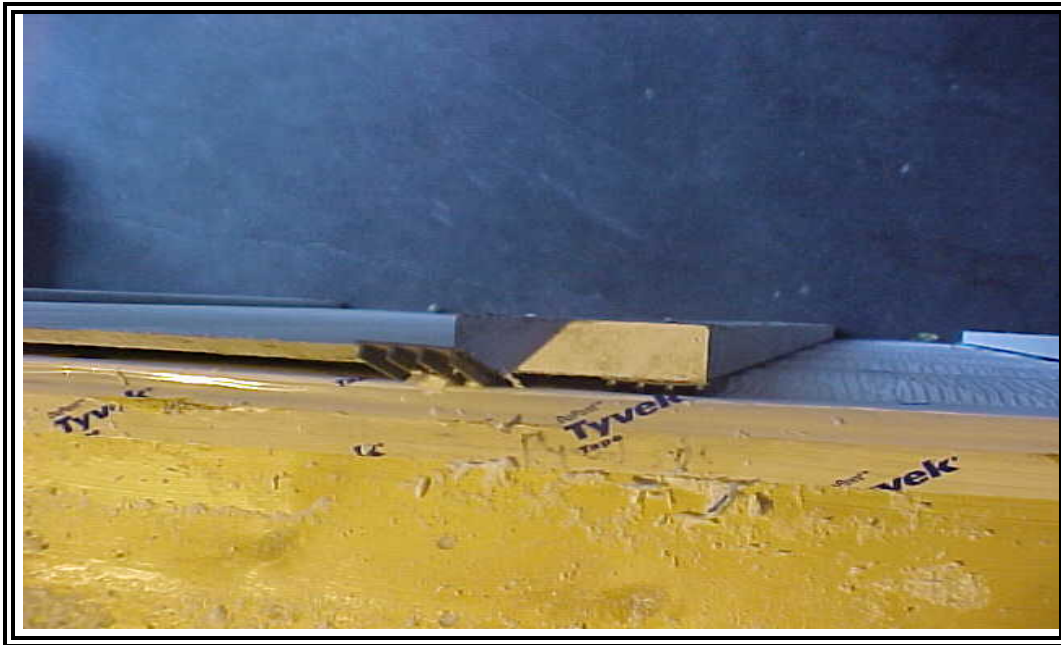
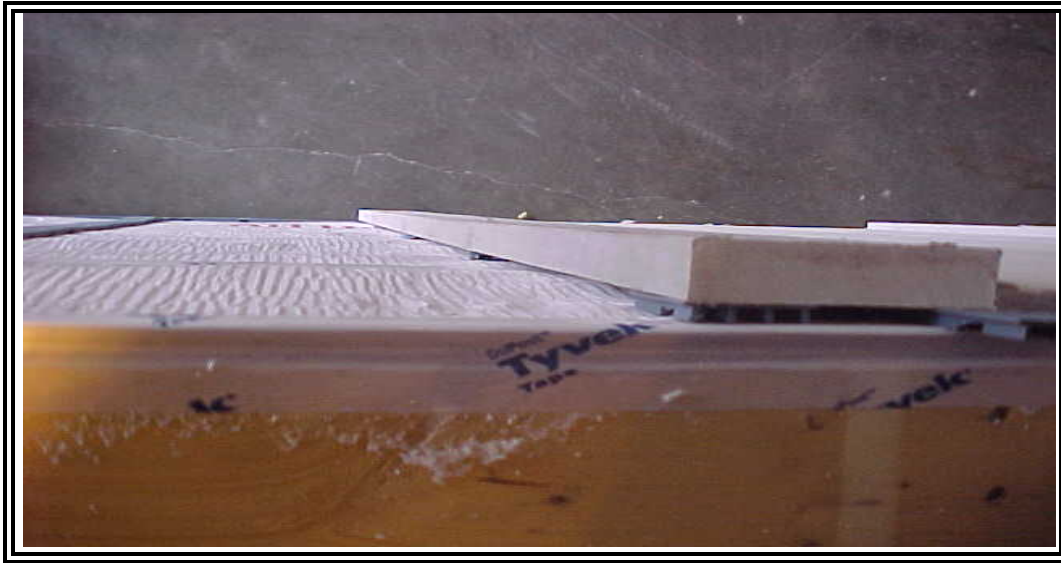
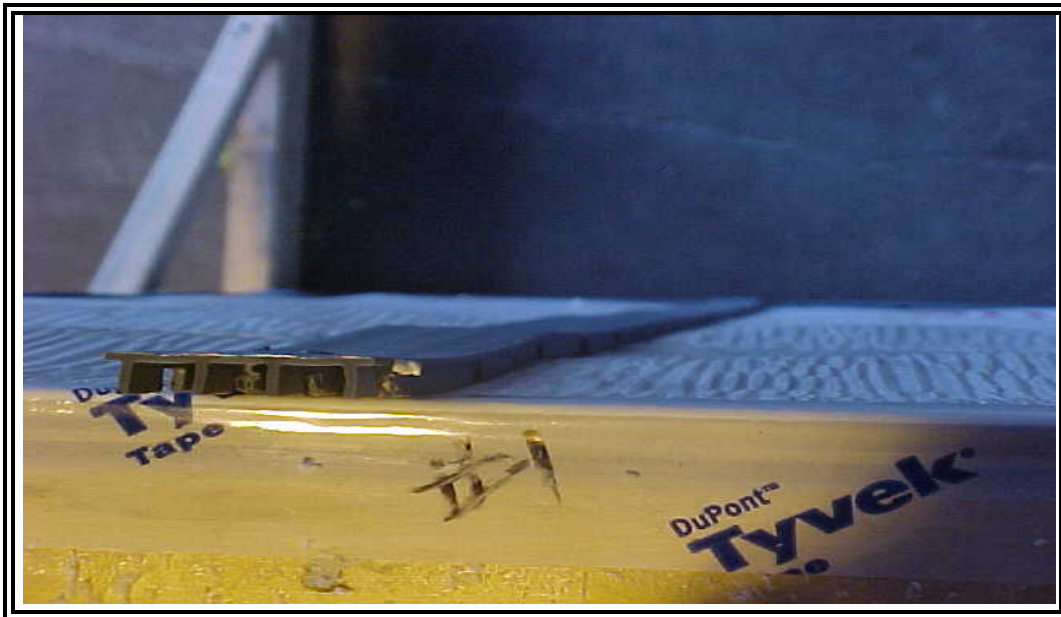
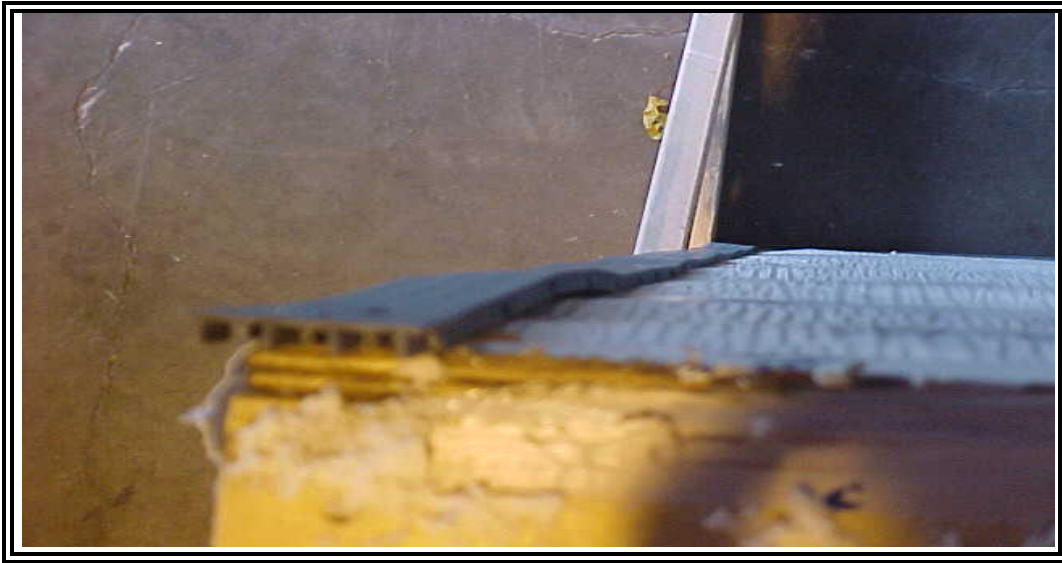
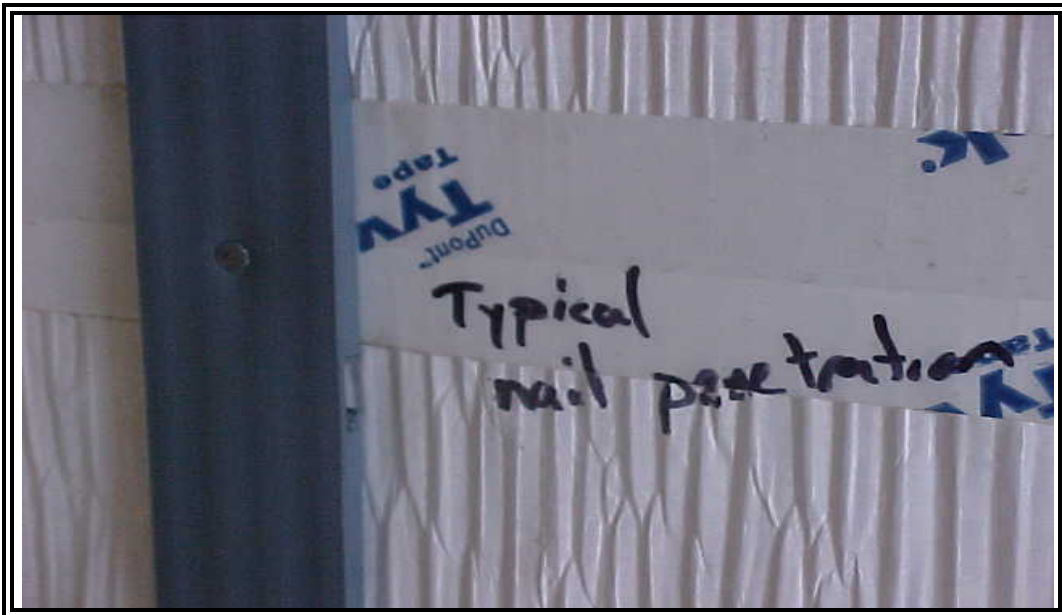
Photos (After Test)

- No visual or siding deformations were observed on the exposed product through completion of test. There was no significant shape change in the covered spacers to affect the appearance of the exterior siding. (See photos)
